# Magic Bullet NutriBullet Pro Rubber Gasket Replacement

Use this guide to replace a damaged rubber gasket on a Magic Bullet NutriBullet Pro for a tight seal that prevents leaks. If the seal is cracked or ripped it will continue to leak.

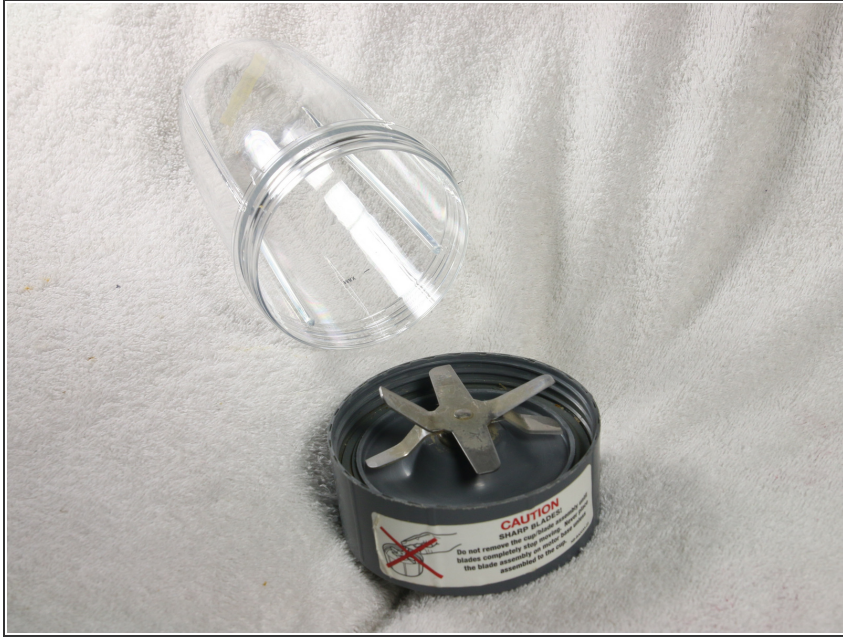
## Step 1 — Rubber Gasket

- Unscrew the blending blade lid from the cup.

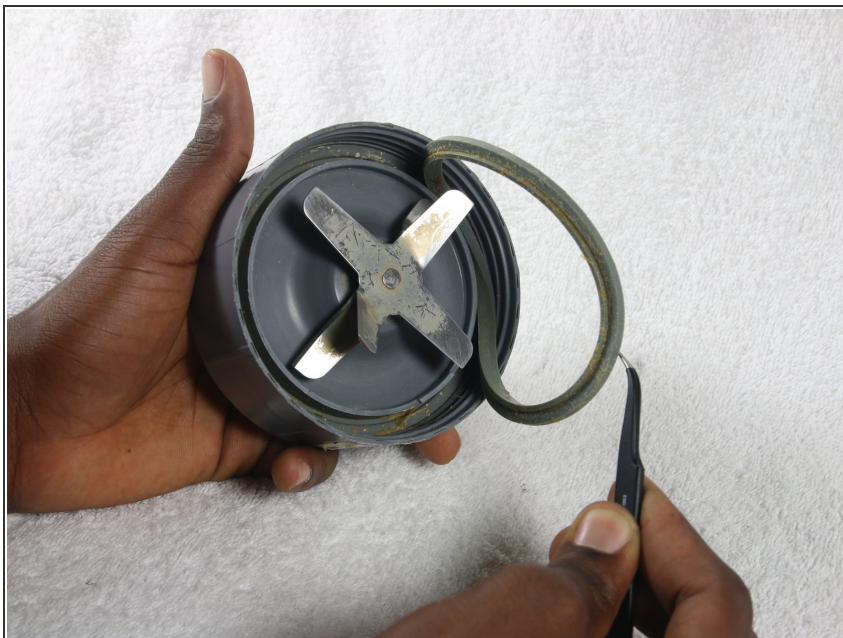
## Step 2

- Use tweezers to peel back the rubber gasket that surrounds the inner ring of the lid.

To reassemble your device, follow these instructions in reverse order.
